## Danish EPA-NR pilot studies

# **Overall report on the pilot projects**

**Energy Performance Assessment  
of Existing Non-Residential Buildings**

# Overall report on pilot projects

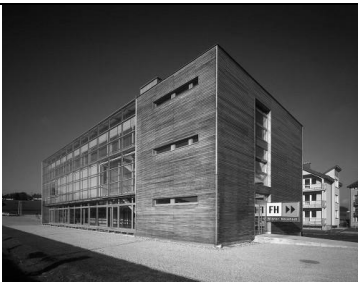
Location And general information	Photo
  <p><b>Austria</b></p> <p>Gross area: 6156 m<sup>2</sup> Year of construction: 2002</p>

<p><b>Building envelope:</b> Wooden-frame construction with static elements (inside) made by concrete/ High insulated outer wall components/ .Steel-glaze cladding in the southwest (climate-cladding).</p> <p><b>Heating/cooling:</b> The pellets boiler plant, which is fully automated, guarantees the energy supply for heating and ventilation/ radiators for heating emission/ air conditioned cold water is used for cooling units on the second floor / The change from heating to cooling happens automatically by the room thermostat/ The whole regulation of the heating and ventilation system works on a DDC-System. Handling of the power control is done by a central building control system.</p> <p><b>Ventilation :</b> The toilets on each floor are vented by ventilators. In the laboratories on the basement two exhaust air plants are installed - The exhausted air is re-feed by the two-staged delivery air plant in every single room. Both of the lecture rooms and the seminar room at the ground floor are equipped with an independent delivery and exhaust air plant with heat recovery.</p> <p><b>Lighting:</b> Conventional fluorescent tube lighting with manual switching.</p>

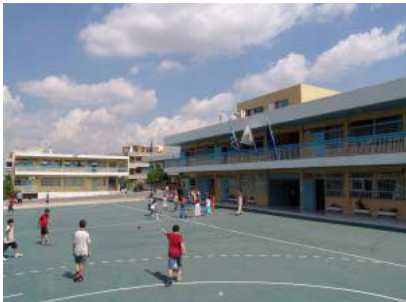
<p><b>Athens/Greece</b></p> <p>Primary school and Kindergarten Gross area: 2709 m<sup>2</sup> Year of construction: 5 buildings, built in different stages 1970, 1976 and 1989</p>

<p><b>Building envelope:</b> Among the five buildings only one is thermally insulated, the other four have only roof insulation. Brick walls with concrete rendering. Single glazed windows with aluminium frames and internal curtains.</p> <p><b>Heating/cooling:</b> Two central oil fired boilers for space heating/ electric heaters for DHW/ceiling fans in offices.</p> <p><b>Ventilation:</b> Natural ventilation.</p> <p><b>Lighting:</b> Fluorescent tubes.</p>
  <p><b>Fiuggi/Italy</b></p> <p>Gross area: 2380 m<sup>2</sup> Year of construction: 1932</p>

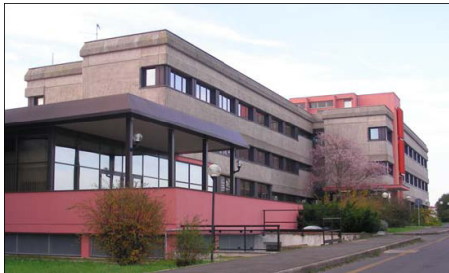
<p><b>Rome/Italy</b></p> <p>Gross area: 3200 m<sup>2</sup> Year of construction: 1990</p>

<p><b>Building envelope:</b> External insulation/reflective double glazing windows with aluminium frame without thermal break/ no insulation in concrete ground floor.</p> <p><b>Heating/cooling:</b> Gas boiler for heating and chillers with cooling tower for cooling/ fan coil units are used as emission system/ electric boilers for DHW.</p> <p><b>Ventilation:</b> Two air handling units are installed for offices, these AHU are also used for heating and cooling and ventilation for conference room.</p> <p><b>Lighting:</b> Fluorescent lamps.</p> <p><b>Specific aspect:</b> The stairs volume should be in principle separated by the heated volume by double glazed doors but in practice these doors are always open.</p>
